PUBLIC ROADS

A JOURNAL OF HIGHWAY RESEARCH

VOL. 22, NO. 10

Page
Bituminous Treatment of Sandy Soil Roads in Nebraska	215
Effect of Carbon Black on the Strength of Mortar	231

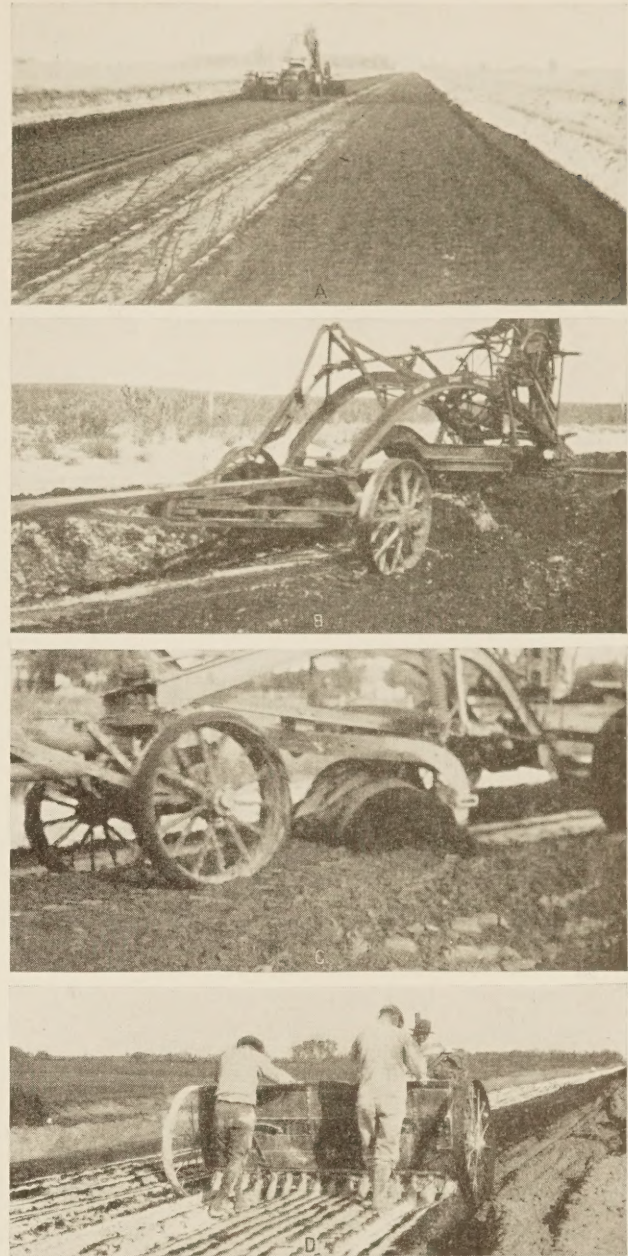
FIGURE 2.—APPEARANCE OF THE SURFACE DURING CONSTRUCTION. A, BLADE GRADER SPREADING THE TOP 2 INCHES OF THE SURFACE; THE REMAINING WINDROWS CONTAIN MATERIAL FOR THE SHOULDERS. B, THE EQUIPMENT USED WAS ILL-SUITED TO PERFORM THE WORK REQUIRED OF IT. C, IN COLD OR COOL WEATHER THE MIXTURE WAS TOO ROPY TO MIX WELL AND WAS PICKED UP BY THE WHEELS. D, SPREADING LIMESTONE DUST WITH A DRILL-TYPE SPREADER.

Figure 2-A shows the top 2 inches being spread for compaction by traffic. Figures 2-B and 2-C are other views of the mixing operation and show the type of

equipment used. The cup-shaped rims of the steel wheels shown in figure 2-B were presumed to prevent side slip but were not effective in this respect. The difficulty in attempting to road-mix in cold weather is illustrated in figure 2-C. The mixture was very ropy and could not be mixed. The sticky mixture adhered to the wheels, making the blade difficult to handle and hard to pull.

The limestone dust used on the B sections was spread with the spreader illustrated in figure 2-D. When applying dust to the bottom 2 inches, a tractor was needed to pull the spreader, but on the top 2 inches a truck was satisfactory most of the time. Figures 3-A, 3-B, and 3-C are photographs taken at stations 506 and 507. Figures 3-A and 3-B show the same area before and after bituminous construction. The cut shown in figure 3-A had to be brought back to grade twice before the bituminous mat was built. Wind-borne sand built up some portions and the wind removed sand from other portions so that no advantage was gained by bringing the surface to grade very far ahead of construction. Figure 3-B shows the same area after the bituminous surface was constructed. The shoulders and slopes have been covered with prairie hay to reduce wind and water erosion.

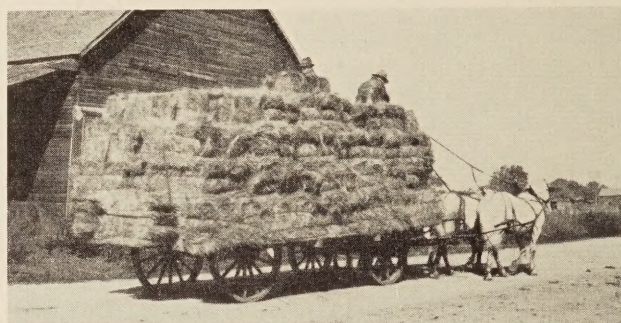
FIGURE 4.—LOADS OF THIS CHARACTER MADE UP THE BULK OF THE TRAFFIC, OTHER THAN MOTOR VEHICLES, THAT USED THE ROAD.

Figure 3-C is a view looking south from station 506 and shows typical sand-hill country. The trails paralleling the new road on both sides were used in preference to the old sand road. Figure 4, shows the most prevalent type of traffic, other than automobiles, that used the road. The gross load of this wagon was 8,430 pounds and was carried on wheels with 4-inch steel rims. The front wheels carried 410 pounds per inch width of tire and the rear wheels carried 644 pounds. Although the day on which the photograph was taken was warm and the cut-back section on which the vehicle traveled was not well compacted, the wheels while moving did not cut into the surface. They did mark the surface definitely but the marks were later ironed out by other traffic. Traffic such as that illustrated is fairly heavy during marketing season and, as the shipping point is O'Neill, all loaded vehicles traveled in the same direction and used the same side of the road. This concentration of relatively heavy traffic had no noticeable effect on the road surface.

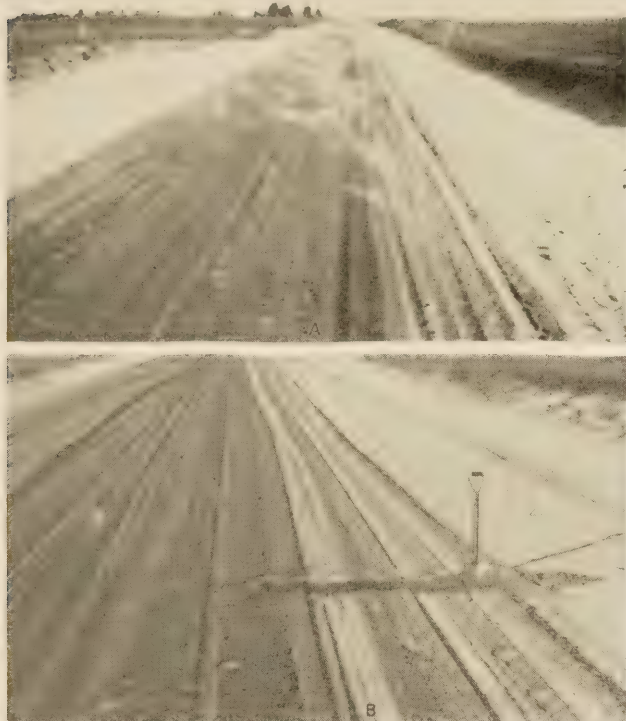
FIGURE 5.—A, SAND DRIFTING ACROSS A CUT-BACK SECTION. THE WIND WAS BLOWING TOWARD THE CAMERA AND AT A SLIGHT ANGLE TO THE CENTERLINE OF THE ROAD. B, DRIFTED SAND ON A LOOSE, ROAD-OIL SECTION. THE SPADE MARKS THE RIGHT EDGE OF THE BITUMINOUS MAT.

After a cut-back section had been laid down and had received even a small amount of compaction, drifting sand did not remain on the surface but was carried across it. Figure 5-A shows sand drifting across a cut-back section. It will be noted that where the surface has been made smooth by pneumatic tires, the sand is not intercepted but is filling the depressions made by

the tractor cleats and also has covered the edges. On the road-oil sections the moving sand was more troublesome as it remained on the surface in considerable amounts and at one time, as illustrated in figure 5-B, nearly filled the side ditch and completely covered a 2-foot strip of the oiled-sand mat. It has become common practice more recently to use ordinary snow fence to control the drifting of sand in bad areas, not only as an aid during construction operations but also as a protective measure for the finished road.

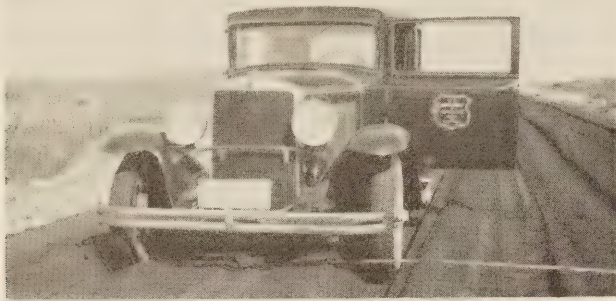
FIGURE 7.—THE ROAD-OIL SECTIONS REMAINED IN A LOOSE CONDITION EXCEPT IN COLD WEATHER. AFTER FINE SOIL FILLER WAS ADDED THE MIXTURE COMPACTED AND BECAME STABLE.

Since the bituminous material in the road-oil sections 7A, 7B and 8A contained practically no volatile material that would be lost at normal temperatures, little permanent change in viscosity occurred except that caused by weathering. Consequently, with the return of warm weather in the spring following construction, the sections containing the road oil gradually softened and lost the bond they had during cooler weather. They were soon in the same loose, uncompacted state in which they had been immediately after construction. When in this condition, illustrated in figure 7, travel was difficult and traffic followed a single lane until the ruts that were formed extended below the bottom of the mat and travel became almost impossible. It was realized that some modification of the road-oil sections was necessary in order to increase their stability sufficiently to carry traffic in warm weather.

After the soil filler was added, the road-oil sections remained in good condition for 5 years and required practically no surface maintenance. Figure 9-A, a view taken in October 1935, shows the typical condition of these three sections during this period, which is in marked contrast to their early appearance, as shown in figure 7.

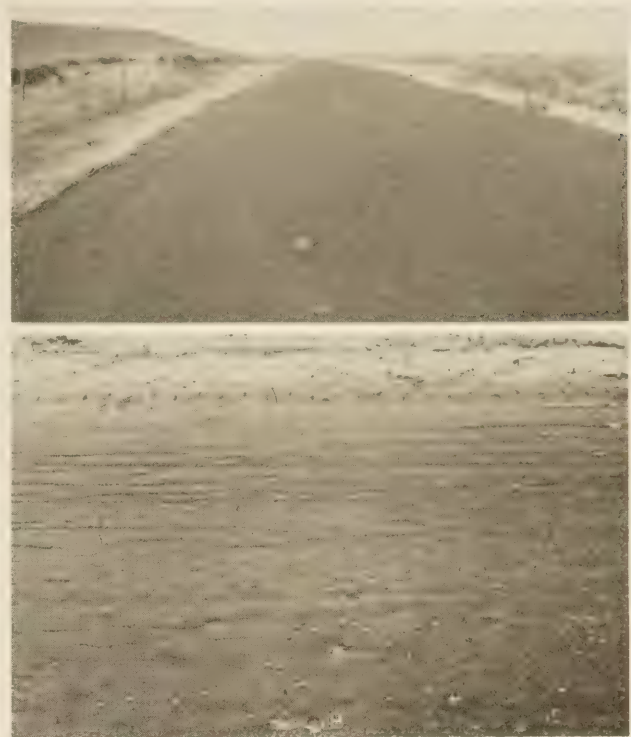
FIGURE 9.—ROAD-OIL SECTION AFTER ADDITION OF FINE SOIL FILLER. A, NOTE VEGETATION COVERING THE SHOULDERS AND SLOPES; B, CRACKING APPEARED IN THE OUTER WHEEL LANE, AND ROUGHNESS, DUSTING, AND POT-HOLING DEVELOPED.

Some dusting of the surface and pot-holing began to appear in 1937. Cracking also appeared in the outer wheel lanes, caused primarily by lack of shoulder support. This condition is shown in figure 9-B. The sections were surface-treated in May 1938 with 0.3 gallon of RC-2 cut-back² and 35 pounds of pit-run gravel per square yard. This treatment was beneficial in eliminating the previous defects. Maintenance through the spring of 1940 was practically negligible. The cost of maintaining, reconstructing, and surface-treating these sections is given in table 6.

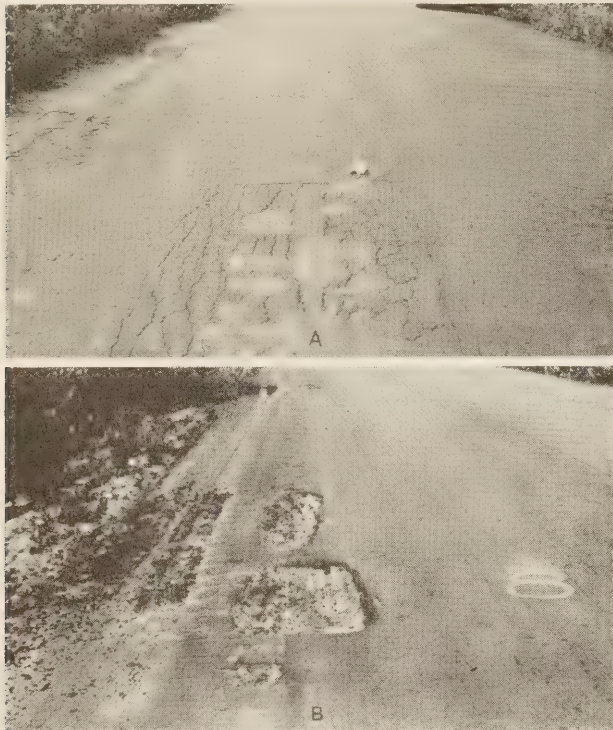
FIGURE 10.—PLACES WHERE SURFACE FAILURE OCCURRED. A, THE RECTANGULAR PORTION IN THE CENTER WAS REMIXED AND TAMPED BY HAND; SHINY AREAS ARE POOLS OF BITUMEN. B, BREAK-UP CAUSED BY UNTREATED SAND LYING BETWEEN UPPER AND LOWER PORTIONS OF THE MAT.

Maintenance of the surface prior to 1935, excepting the work described, consisted mainly of routine patching to fill depressions caused by standing vehicles, repair of raveled areas, and small replacements where the mat broke. In practically all of these small break-ups it was observed that the part of the mat that broke was very thin and that untreated sand lay between it and the mat below it. Figure 10-B shows several areas that failed from this cause, which was a construction defect.

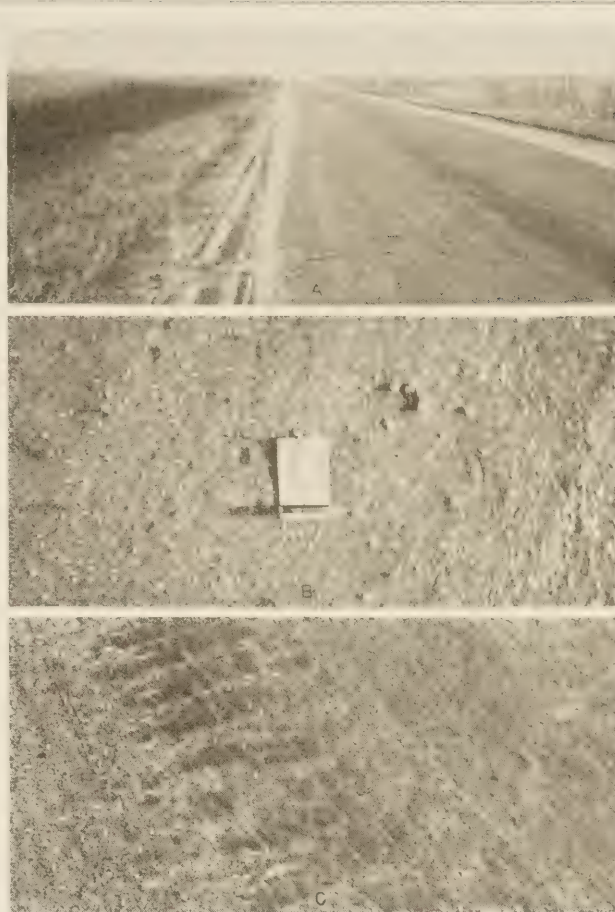
FIGURE 11.—A, CUT-BACK SECTION AFTER RE-TREATMENT. THE GRASS LINE MARKS THE EDGE OF THE ORIGINAL BITUMINOUS MAT AND THE ARROW MARKS THE EDGE OF THE RE-TREATMENT. LOOSE MATERIAL NEAR THE EDGES HAS BEEN WHIPPED TO THE SIDES BY TRAFFIC. B, APPEARANCE OF THE SURFACE IMMEDIATELY AFTER RE-TREATMENT. C, APPEARANCE OF SECTION 9A 3 YEARS AFTER SURFACE TREATMENT. THE DARK STRIP IS THE AREA BETWEEN WHEEL TRACKS AND IS SLIGHTLY RAISED.

As might be expected from the method of applying the treatments without manipulating the bitumen and cover, the resulting surfaces were not uniform in appearance generally. More bitumen and cover were held in the depressed areas, obviously, than on the higher areas. The cracks were sealed but they were covered only in the depressed areas where the surface treatment mat was of appreciable thickness. Figure 11-C is a view of the surface of section 9A 3 years after it was surface treated and is typical of the surface texture obtained by the treatments.
